Phase IA Background Review and Archaeological Assessment, Ringwood Mines/Landfill

Superfund Site (NJD980529739) Operable Unit (OU) 2 Borough of Ringwood, Passaic County, New Jersey

# Phase IA Background Review and Archaeological Assessment Ringwood Mines/Landfill Superfund Site Operable Unit 2 Borough of Ringwood, Passaic County, New Jersey USEPA ID No. NJD980529739

NJ HPO Project # 16-1695-3

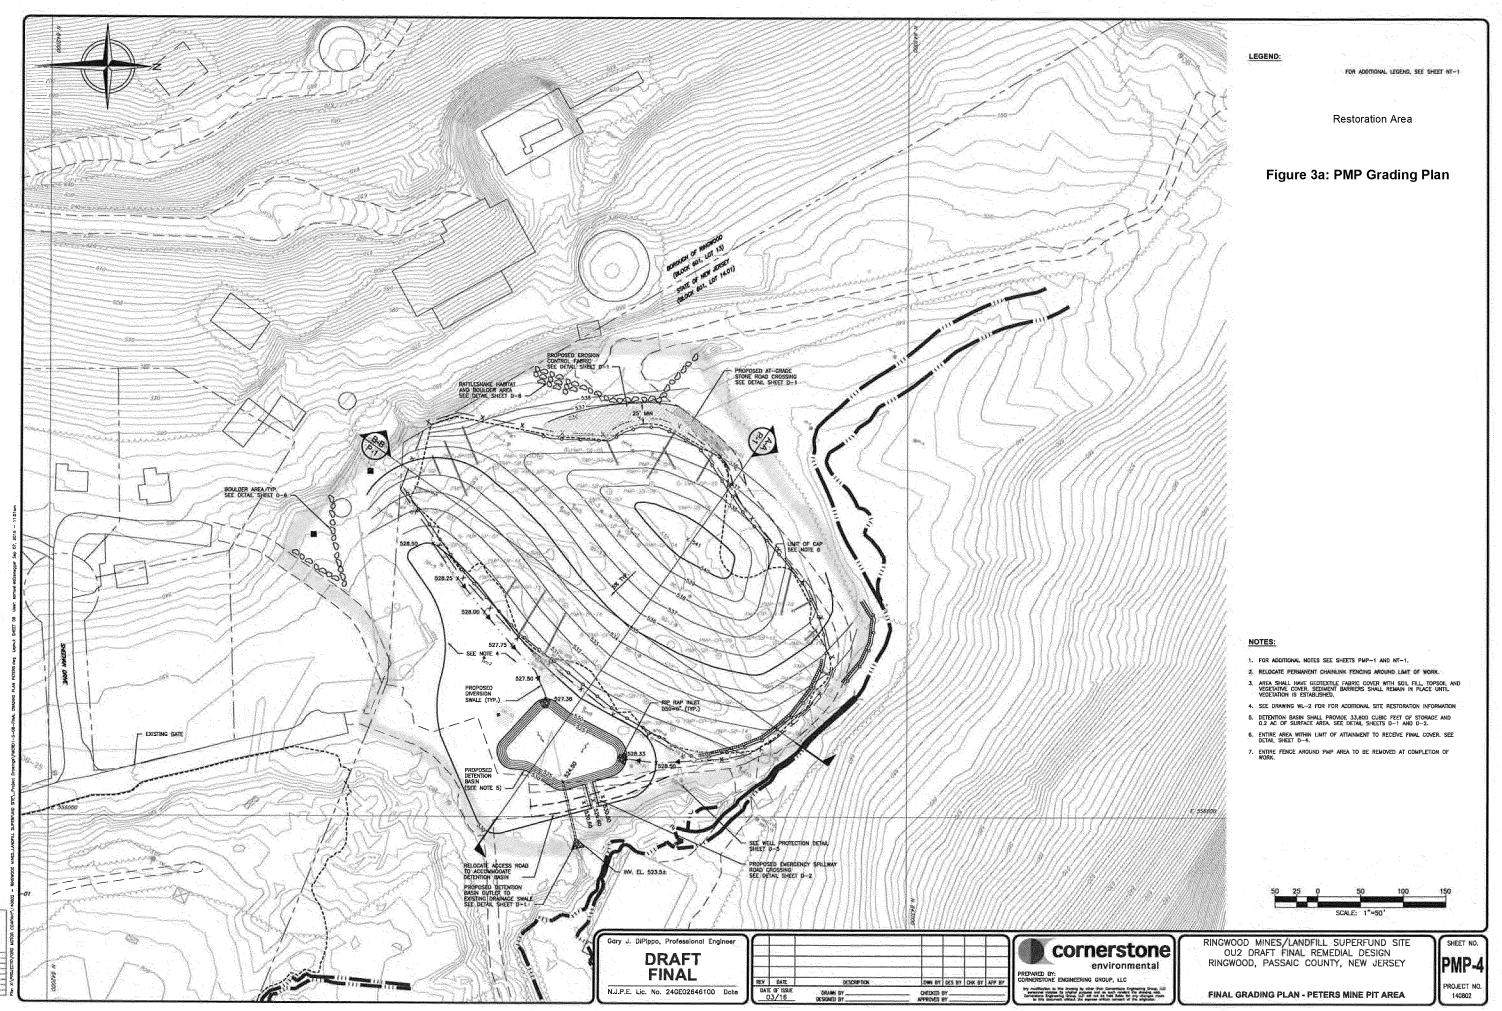
#### PMP Area (Figure 3a)

- Excavation of soil and fill to the water table, unless drums and paint waste are found to extend below
  the water table and can be removed, in which case, excavation will also include such materials;
- Segregation of excavated materials for re-use or off-site disposal based on the nature of the materials and the results of laboratory analyses, as applicable;
- Placement of compacted fill to achieve grades above the water table and provide overall grading of the area as necessary for Engineering Cap construction;
- Installation of an Engineered Geotextile/Soil Cap as an Engineering Control and restoration with indigenous vegetation consistent with Ringwood State Park; and
- Institutional Controls and long-term monitoring, maintenance, and reporting.

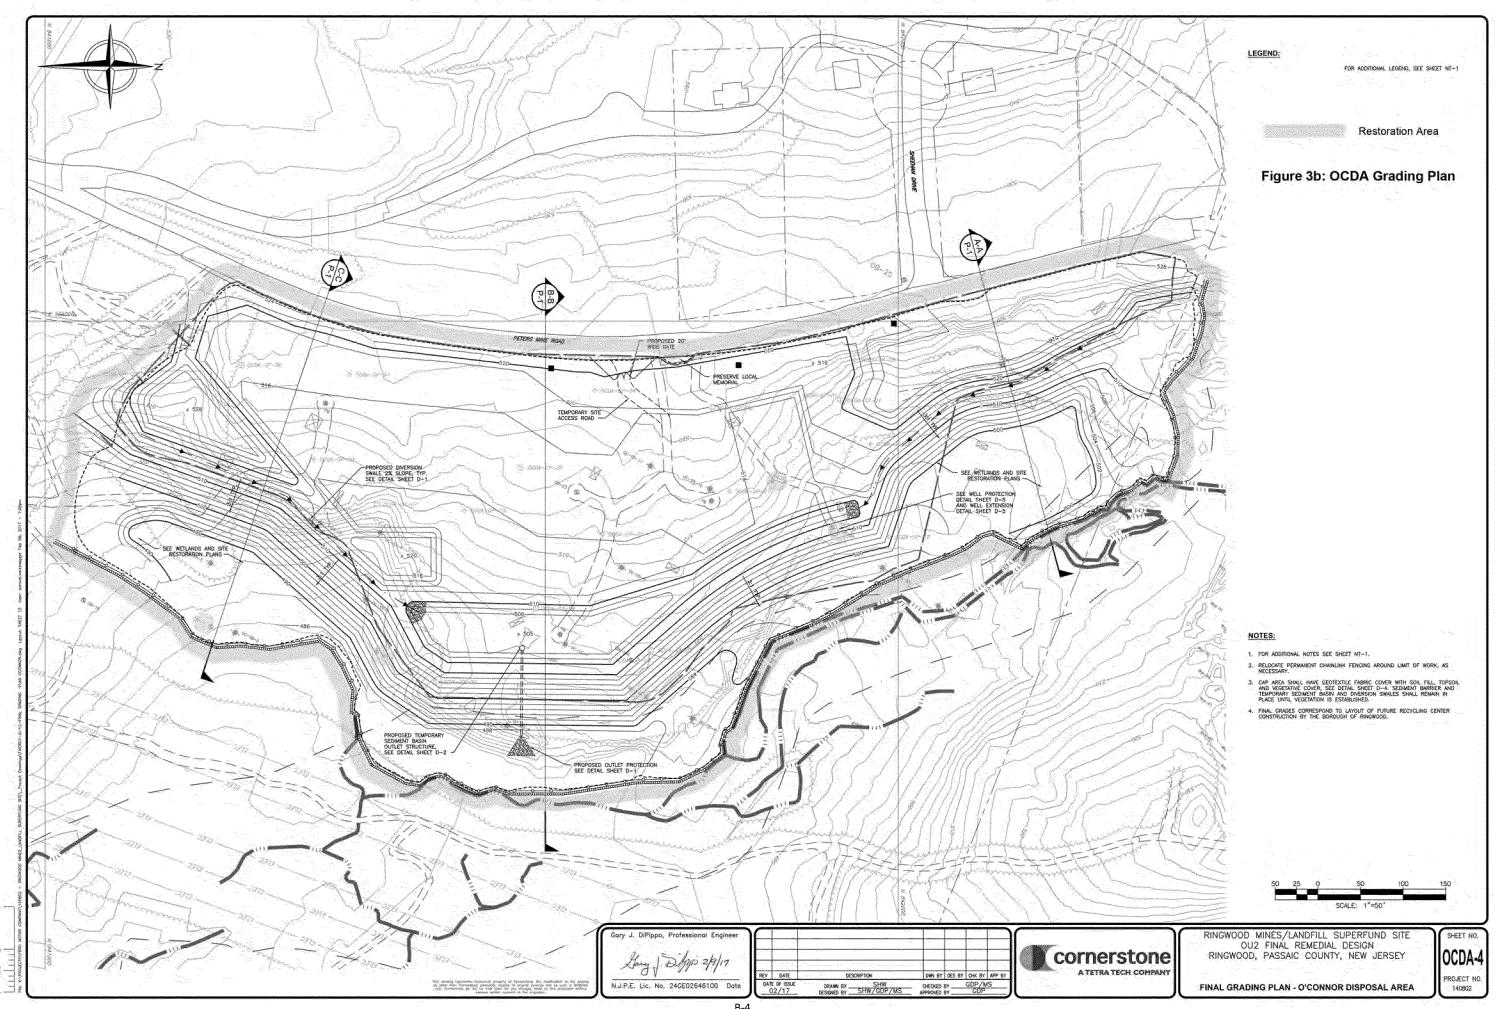
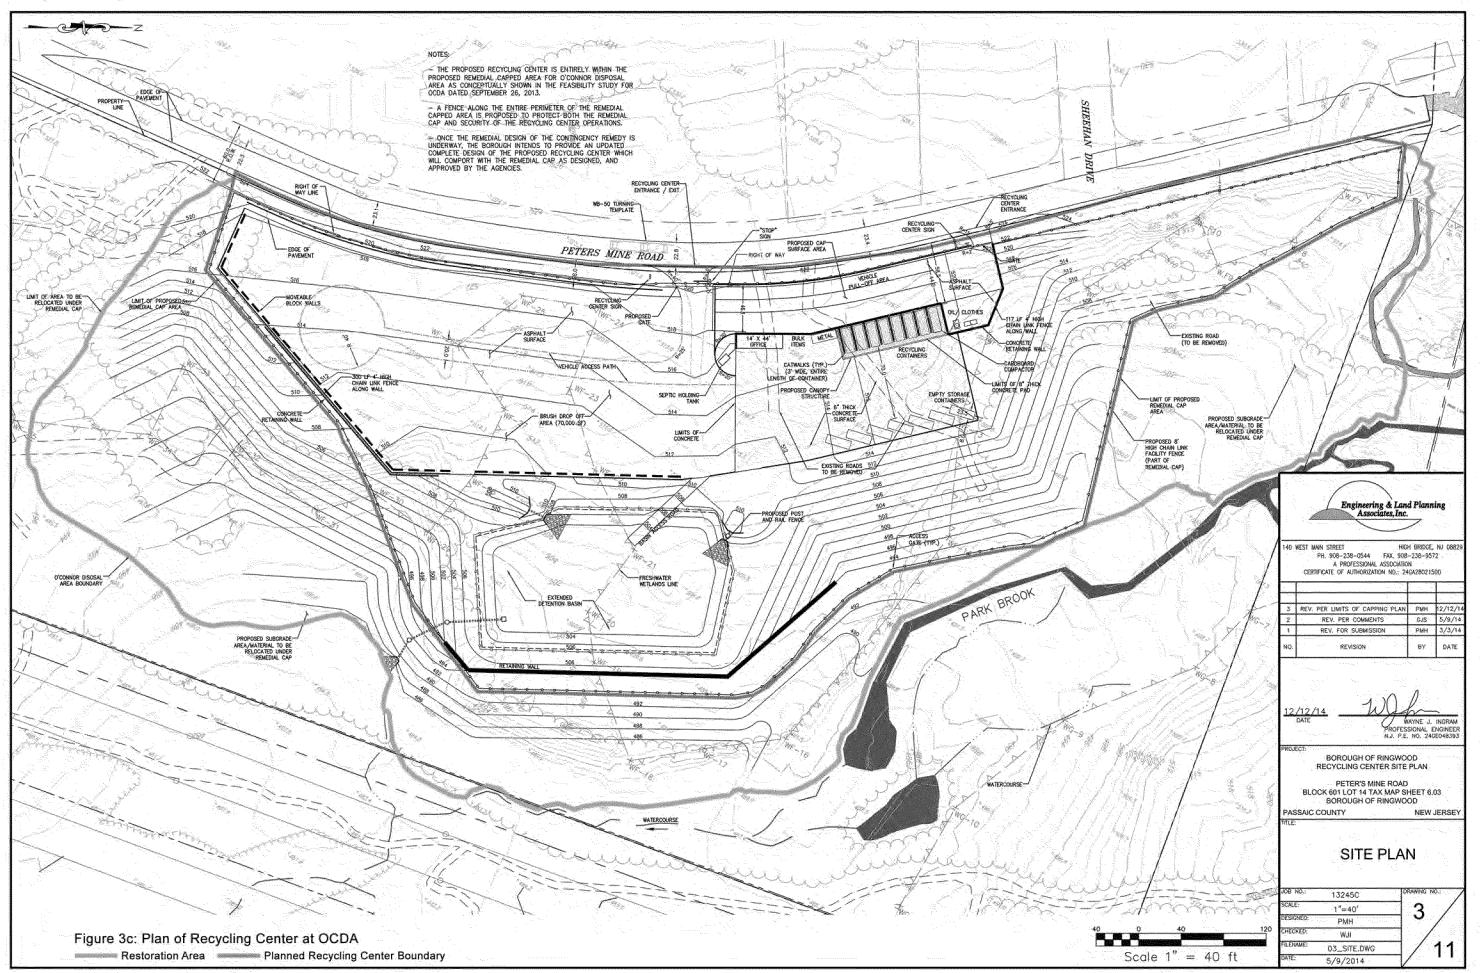
#### OCDA (Figures 3b and 3c)

- Excavation of fringe area fill and consolidation within the OCDA;
- Installation of an Engineered Geotextile and Soil Cap followed by redevelopment of the area above the Engineered Cap as a Recycling Center for the Borough of Ringwood;
- Construction of the Recycling Center above the Engineered Cap once installed which would also function as a protective feature above the cap (e.g., asphalt pavement, etc.);
- Additional Engineering Controls (e.g. fencing, signs, etc.) to control access;
- Restoration of vegetation in areas outside of the Engineered Cap;
- Restoration/mitigation of wetlands disturbed by the remedy implementation; and
- Institutional Controls and long-term monitoring, maintenance, and reporting.

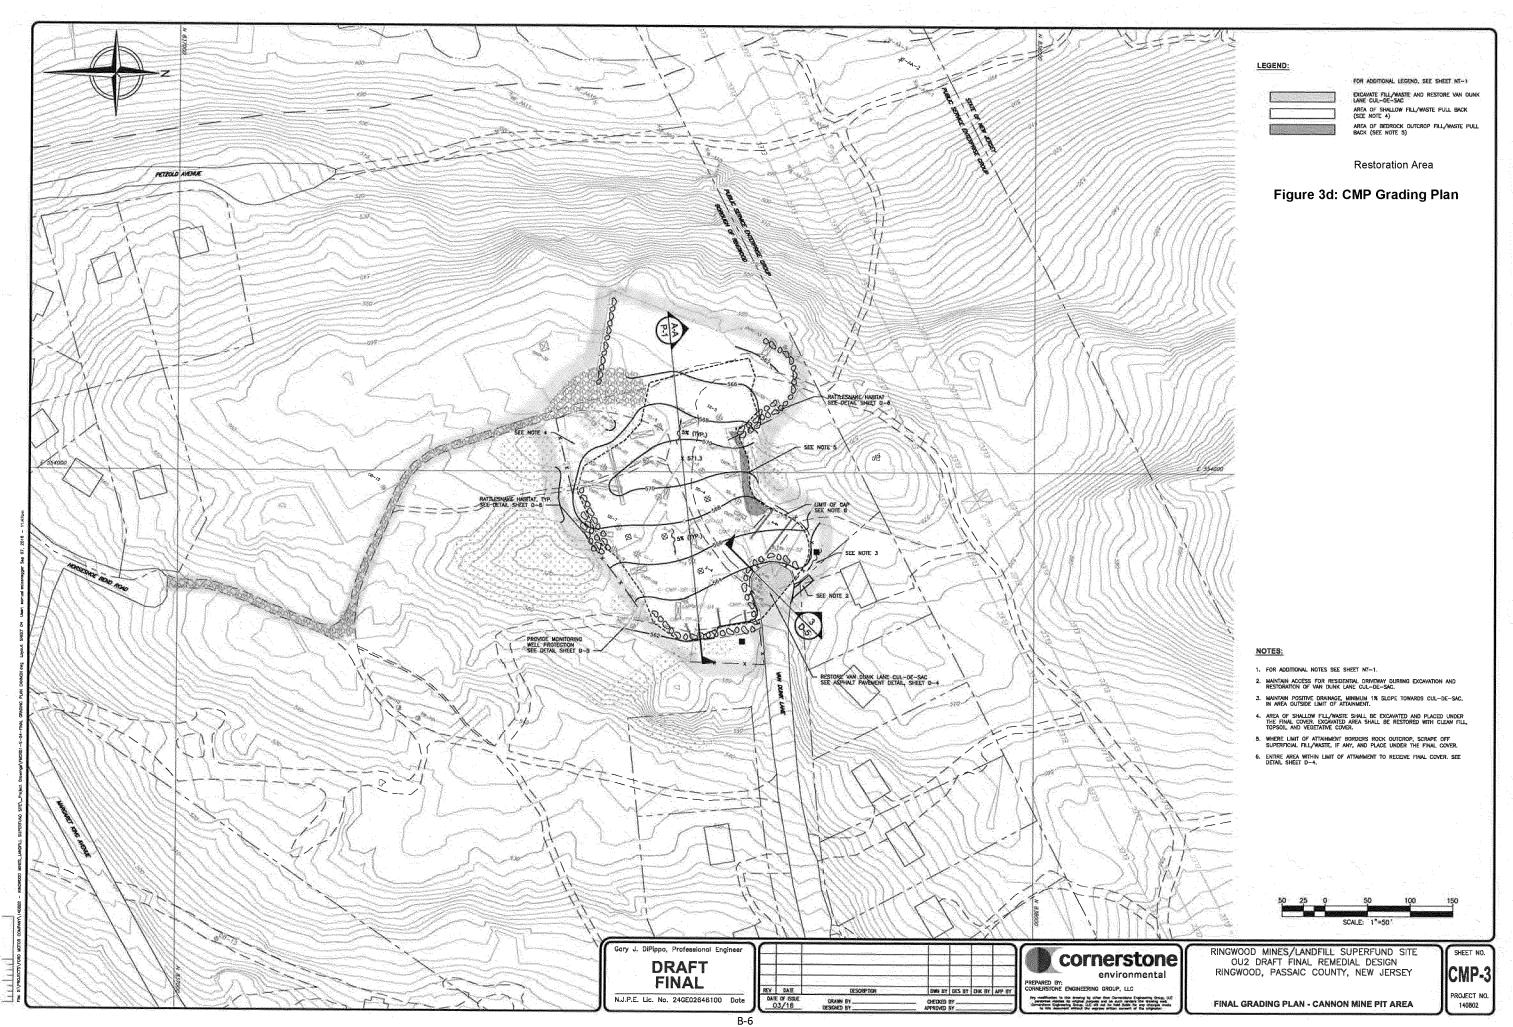
#### CMP Area (Figure 3d)

- Excavation of drums of waste, if any are encountered, and proper offsite disposal;
- Placement of compacted fill to promote proper drainage of the area;
- Installation of an Engineered Geotextile/Soil Cap as an Engineering Control and restoration with vegetation;
- Additional Engineering Controls (e.g., fence, boulders, signs, etc.) to control access; and
- Institutional Controls and long-term monitoring, maintenance, and reporting.

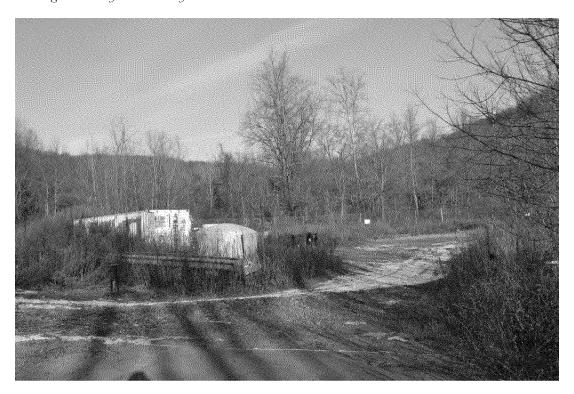
**Photograph 1.** PMP Area--Looking northwest from the end of the pavement on Peters Mine Road. The open area in the foreground is the staging area where vegetation will be stored, and the fenced area behind it is mine pit area where remediation and construction of a fill cap will occur. Photo by C.L. Borstel, Tetra Tech, Inc., January 16, 2017.

The main staging area for remediation activities in the vicinity is an open area located at the end of the paved part of Peters Mine Road. The staging area is relatively flat and appears to have been heavily utilized or graded over a considerable period of time. No standing ruins or foundations were observed within this part of the PMP Area.

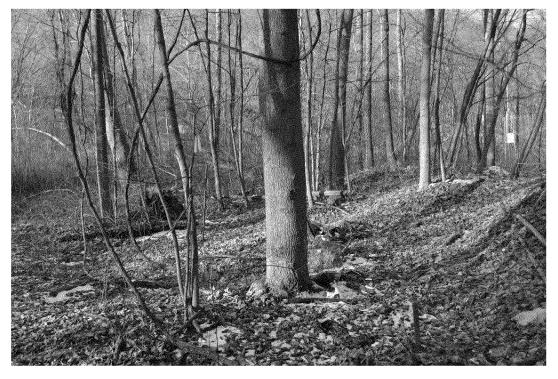
**Photograph 2.** PMP Area—Typical landscape of terrain in remediation area. Looking northeast. Photo by C.L. Borstel, Tetra Tech, Inc., January 16, 2017.

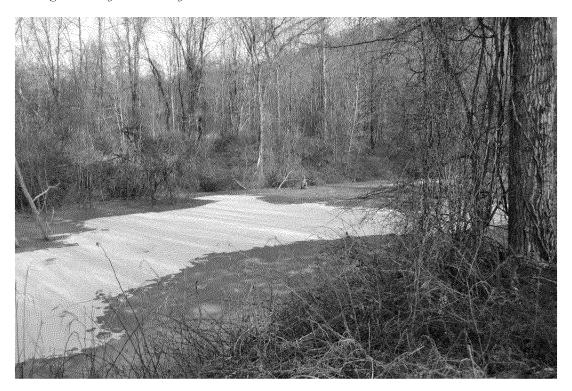
**Photograph 3.** PMP Area—Flooded mine pit in middle of remediation area. Looking south. Photo by C.L. Borstel, Tetra Tech, Inc., January 16, 2017.

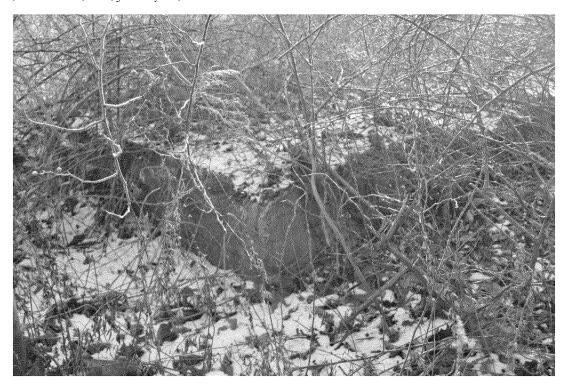
**Photograph 4.** PMP Area—Poured concrete building foundation near the southeastern edge of the remediation area. The foundation was built as part of the U.S. government rehabilitation of Peters Mine during the Second World War. Looking southwest. Photo by C.L. Borstel, Tetra Tech, Inc., January 16, 2017.

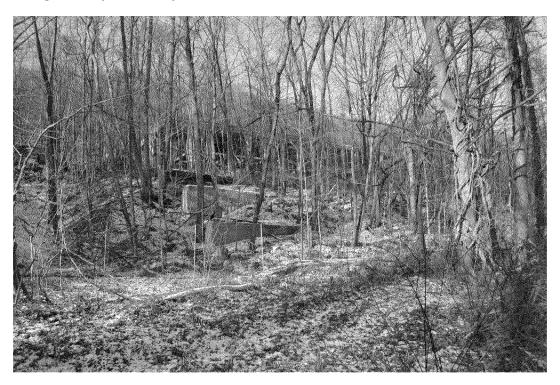
**Photograph 5.** PMP Area—View from southwestern side of remediation area toward ruins of Peters Mine aboveground building complex on hillslope above mine pit. These ruins are the remains of the U.S. government rehabilitation of Peters Mine during the Second World War and are outside the remediation area. Looking southwest. Photo by C.L. Borstel, Tetra Tech, Inc., January 16, 2017.

The remedial action and restoration plans for the PMP Area focus on the former open mine pit, but are not concerned with the 1940s-era ruins of mine buildings on the hillslope southwest of the pit, nor with the abandoned underground mine shafts. After remediation is complete at the PMP Area, vegetation restoration will be completed both on the cap and in the immediately surrounding area, including the staging area at the end of the paved portion of Peters Mine Road.

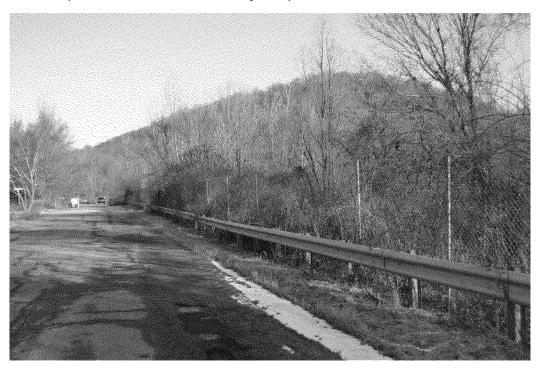
**Photograph 6.** OCDA—Chain link fence along Peters Mine Road marking western edge of the remediation area. PMP Area is at far left in distance. Hope Mountain is in background to right. Looking north. Photo by C.L. Borstel, Tetra Tech, Inc., January 16, 2017.

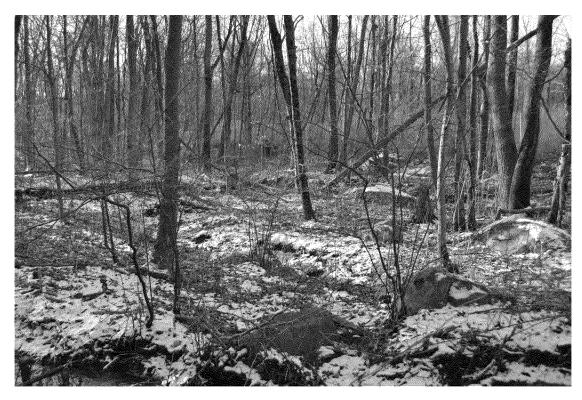
**Photograph 7.** OCDA—Wooded wetland outside northeastern edge of area, looking toward OCDA. Looking southwest. Photo by C.L. Borstel, Tetra Tech, Inc., January 16, 2017.

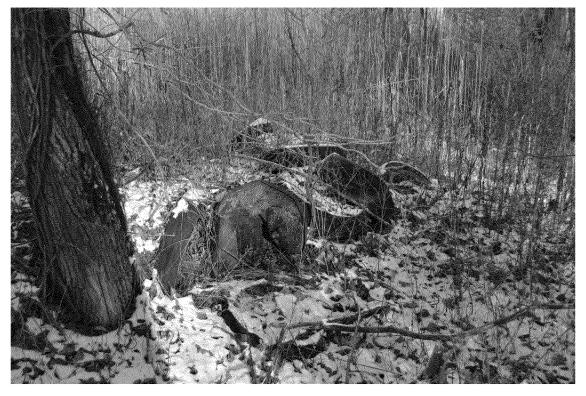
**Photograph 8.** OCDA—Typical hummocky terrain and thick vegetation in the central part of the area. Note refuse on the surface. Looking northwest. Photo by C.L. Borstel, Tetra Tech, Inc., January 16, 2017.

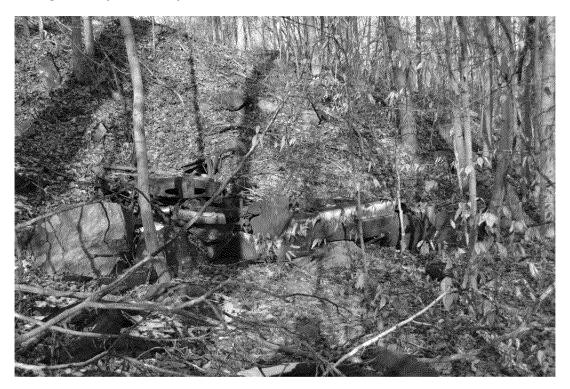
**Photograph 9.** OCDA—Typical sloping terrain and thick vegetation in the southern part of the area. Note surface-exposed angular boulders, some or all of which may be mine tailings, and the metal refuse on the surface. Looking northwest. Photo by C.L. Borstel, Tetra Tech, Inc., January 16, 2017.

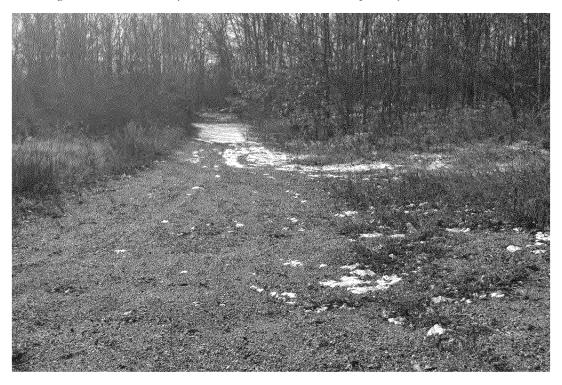
**Photograph 10.** CMP Area—View from vicinity of remediation area along existing gravel access road that connects to the end of Horseshoe Bend Road to the area. Looking south. Photo by C.L. Borstel, Tetra Tech, Inc., January 16, 2017.

Mine. New fencing had been recently installed around it. The CMP Area is accessed by an approximately 600-foot gravel access road in good repair that runs from the end of Horse Shoe Bend Road to the CMP Area. The area where remediation and restoration will take place is on a ridge spur overlooking a small stream. No trees were present within the fenced CMP Area, and examination of aerial photographs indicated that trees were removed from the entire area for remediation investigations that were conducted at CMP between approximately 2007 and 2009. The surface of the CMP Area gently slopes to the northwest— i.e., toward the edge of the valley overlooked by this land AC. The evenness of the slope and lack of any surface debris or topographic irregularities other than one or two piles of very large boulders indicates the area was extensively graded. The rock piles were not mine tailing remnants but were probably imported to the location for landscaping or access management. One fenced area at the eastern end of the CMP Area is a subsurface void, but owing to thick vegetation within and around the fence, it was difficult to get a clear view of the feature. Otherwise, the CMP Area contains no aboveground ruins or foundations on the surface, and judging by the evidence of previous remediation activities and grading, it is unlikely that archaeological traces of any such features have been preserved.

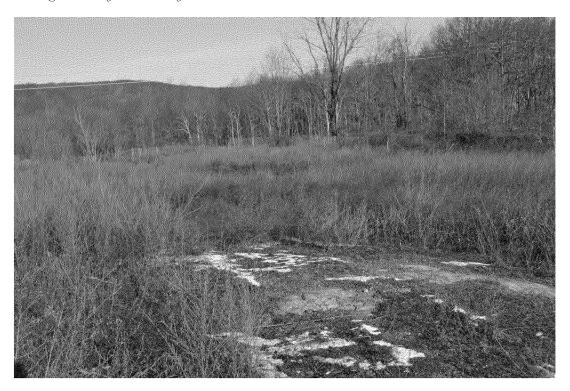
**Photograph 11.** CMP Area—View from southern edge across area. Looking north. Photo by C.L. Borstel, Tetra Tech, Inc., January 16, 2017.

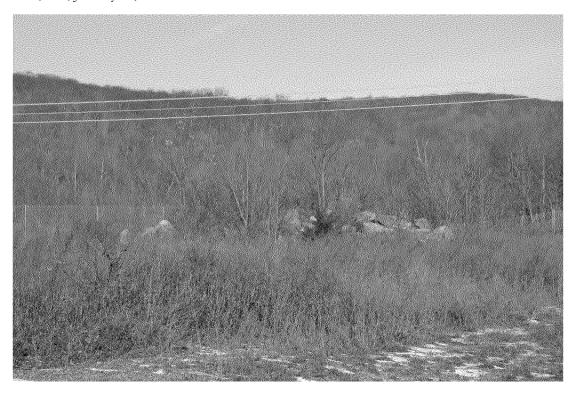
**Photograph 12.** CMP Area—Non-structural pile of boulders at western end of area. Looking northwest. Photo by C.L. Borstel, Tetra Tech, Inc., January 16, 2017.

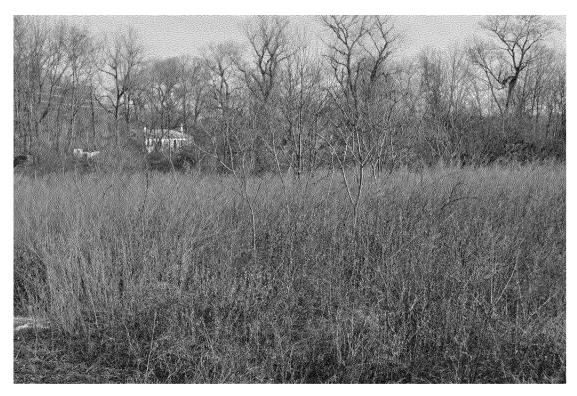
**Photograph 13.** CMP Area—Typical terrain and vegetation of eastern part of area looking toward Van Dunk Lane. Looking northeast. Photo by C.L. Borstel, Tetra Tech, Inc., January 16, 2017.
